Re: Limited Subsurface Exploration & Ground Penetrating Radar Scan
194 Treasure Valley Drive
Nebo, North Carolina
CVET Project No.: 21-753

Project Name: Buchanan Residence
Location: Nebo, North Carolina
Date: July 15, 2021
Project No. 21-753

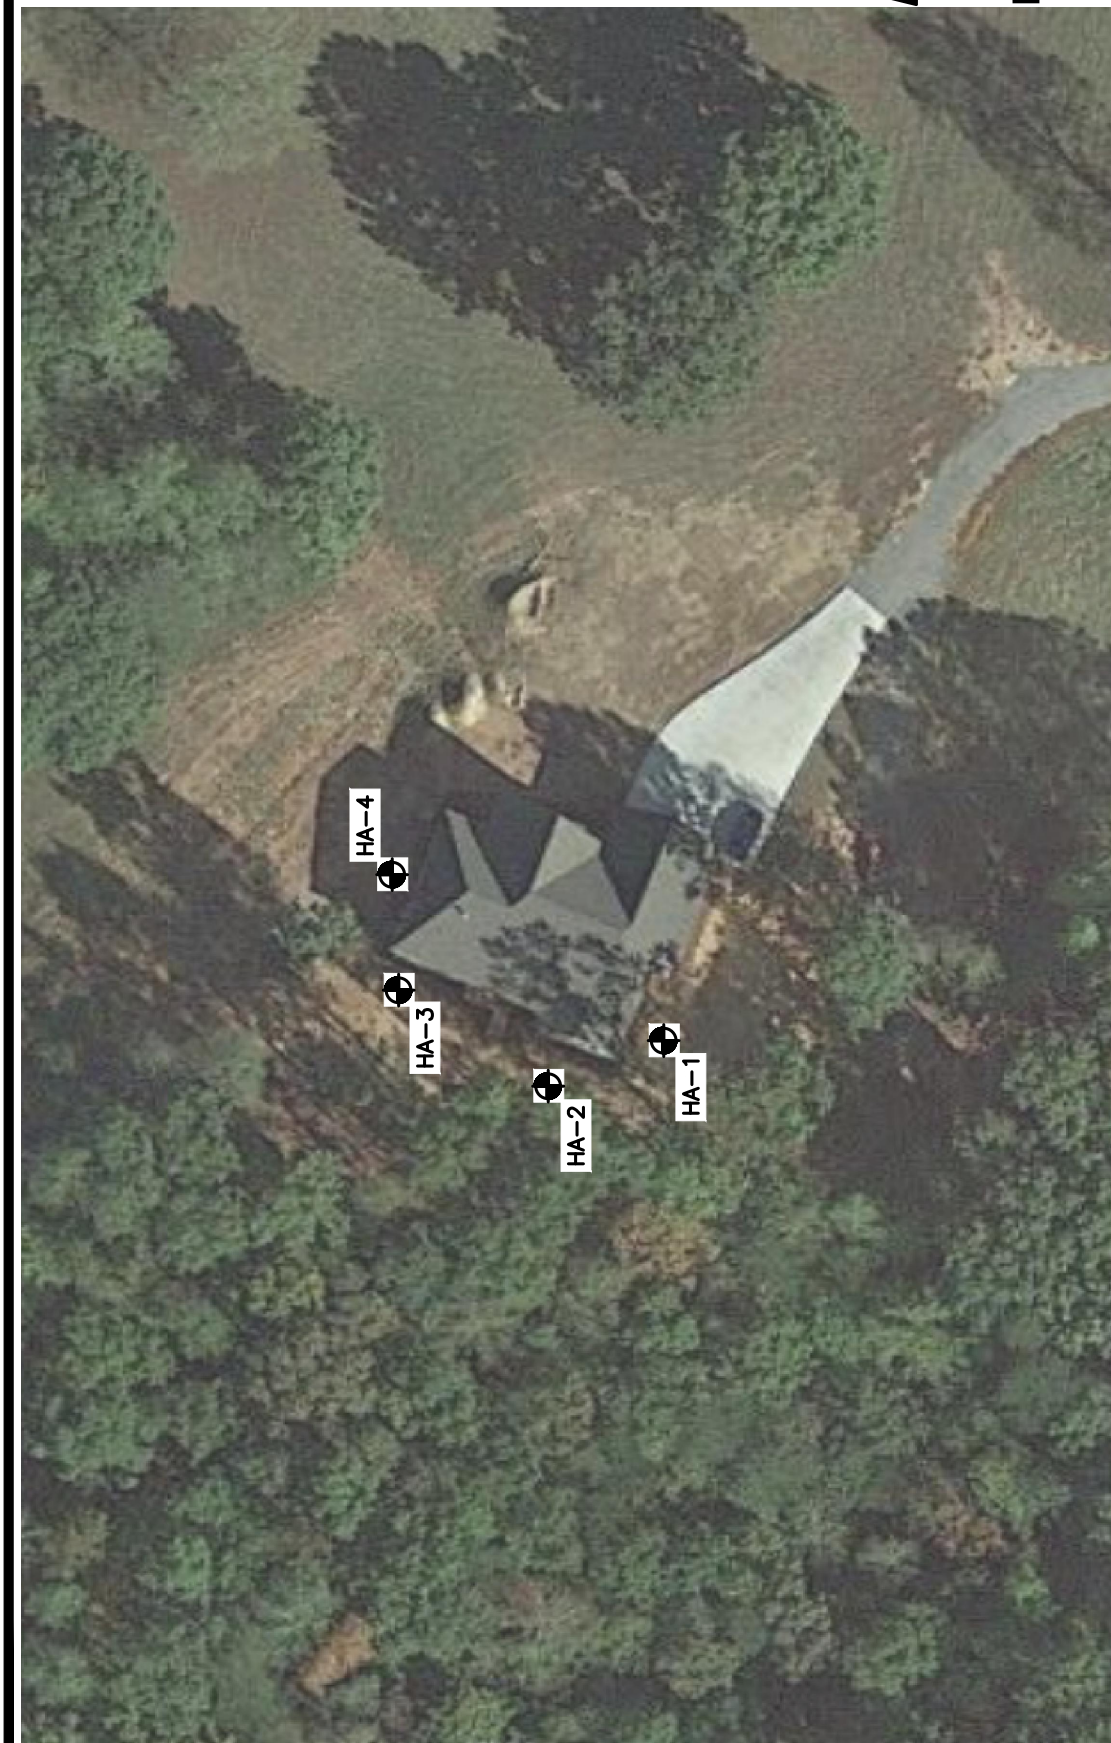
BORING LOCATIONS SCHEMATIC

Hand auger soil test borings were performed on July 2, 2021. On this date CVET personnel performed four (4) hand auger borings at the approximate locations displayed on the attached Boring Location Plan (HA-1 through HA-4). The bore holes were advanced utilizing a hand auger having a three-inch diameter hollow bucket auger with sharpened blades into the soil. Samples of the cuttings were collected from each boring and visually classified. The borings were advanced to a maximum depth of 3.0 feet below existing site grades. The boreholes were backfilled with auger cuttings upon completion and the site was cleaned as best possible prior to demobilization.

Hand auger borings encountered fill soils underlain by residual soils. Borings HA-1 and HA-4 were completed within landscape areas just outside of the perimeter footings.
